**FINAL REPORT
OCTOBER 2002**

REPORT NO. 02-30

**VEHICLE STORAGE AND TRANSPORT FRAME (VSTF),
ENGINEERING EVALUATION TESTS :
MIL-STD-1660, "DESIGN CRITERIA FOR AMMUNITION UNIT LOADS"
TP-94-01, "TRANSPORTABILITY TESTING PROCEDURES"**

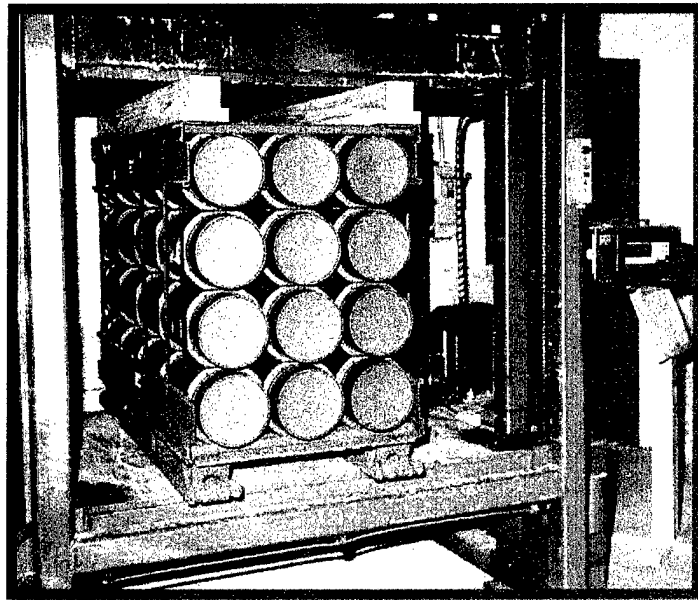
**Photo 1. Example of Compression Tester.
(2.75-inch Hydra 70, PA151 Rocket Pallet in the compression tester.)**

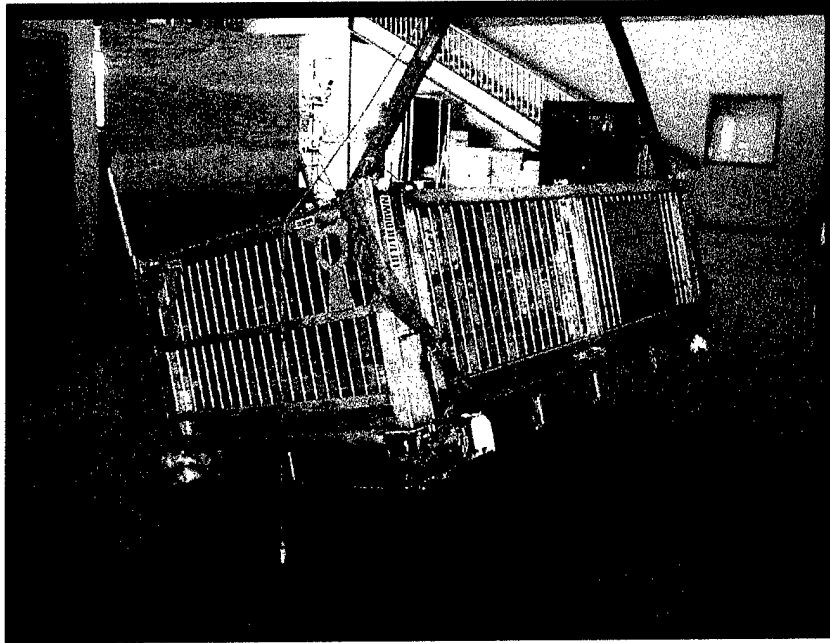
**Photo 3. Example of Edgewise Rotational Drop Test
(Vehicle Storage and Transport Frame)**

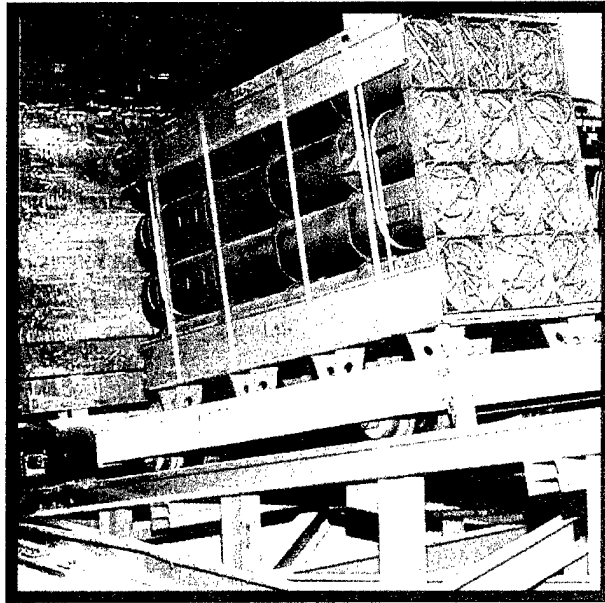
4. INCLINE-IMPACT TEST. This test is conducted by using the procedure of Method 5023, Incline-Impact Test of Federal Standard 101. The procedure for the incline-impact test is as follows: The specimen will be placed on the carriage with the surface or edge to be impacted projecting at least 2 inches beyond the front end of the carriage. The carriage will be brought to a predetermined position on the incline and released. If it were desired to concentrate the impact on any particular position on the container, a 4- x 4-inch timber may be attached to the bumper in the desired position before the test. The carriage will not strike any part of the timber. The position of the specimen on the carriage and the sequence in which surfaces and edges are subjected to impacts may be at the option of the testing activity and dependent upon the objective of the test. When the test is to determine satisfactory requirements for a container or pack, and, unless otherwise specified, the specimen will be subjected to one impact on each surface that has each dimension less than 9.5 feet. Unless otherwise specified, the velocity at the time of the impact will be 7 feet-per-second. Photo 4 shows an example of this test.

Photo 4. Example of the Incline-Impact Test.
(2.75-Inch, Hydra 70, PA151 Rocket Pallet on incline-impact tester.)

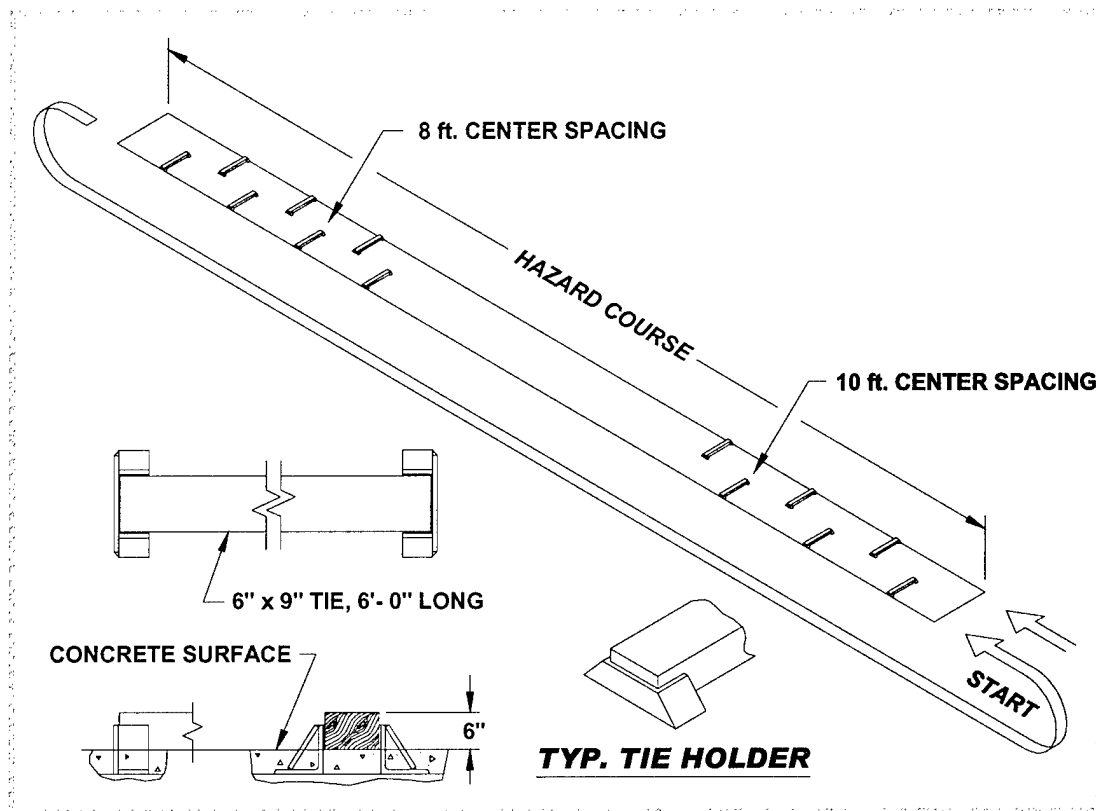
1. **HAZARD COURSE.** The test load or vehicle will be transported over the 200-foot-long segment of concrete-paved road consisting of two series of railroad ties projecting 6 inches above the level of the road surface. The hazard course will be traversed two times (see Figure 2).

Figure 2. Hazard Course Sketch

- a. The first series of ties are spaced on 10-foot centers and alternately positioned on opposite sides of the road centerline for a distance of 50 feet.
- b. Following the first series of ties, a paved roadway of 75 feet separates the first and second series of railroad ties.
- c. The second series of ties are spaced on 8-foot centers and alternately positioned on opposite sides of the road centerline for a distance of 50 feet.
- d. The test load is driven across the hazard course at speeds that will

produce the most violent vertical and side-to-side rolling reaction obtainable in traversing the hazard course (approximately 5 mph).

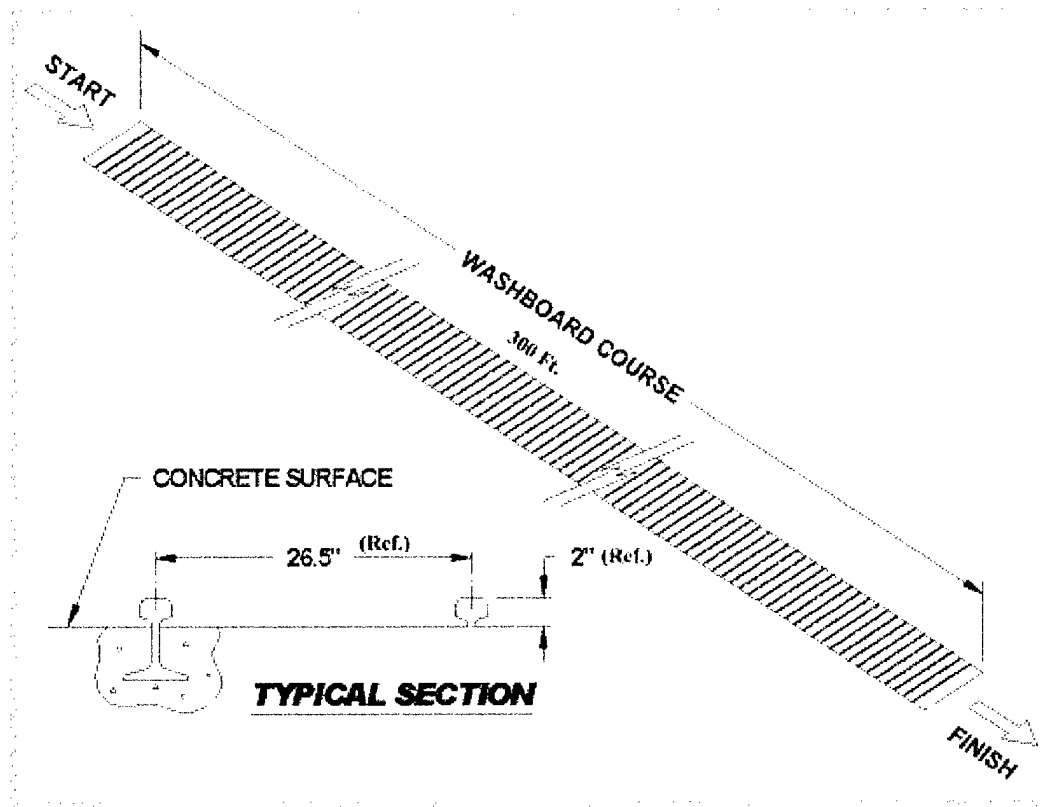
4. **WASHBOARD COURSE.** The test load or vehicle will be driven over the washboard course at a speed that produces the most violent response in the vertical direction.

Figure 3. Washboard Course Sketch

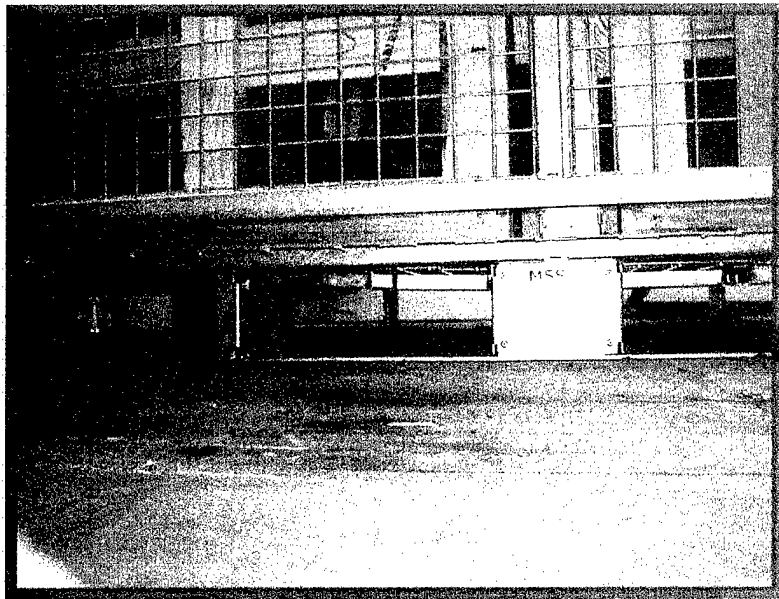
2. **REPETITIVE SHOCK TEST.** The specimen was vibrated 90 minutes at 234 RPM in the longitudinal orientation. During testing the outside tabs on the top shelves failed. The payload could be accessed without disassembly of the VSTF. Photo 6 shows one of the damaged tabs. Testing was suspended due to the tab failure. A second VSTF was assembled and wooden dunnage was added to the load. Also, reinforcement was added to the tabs of the top shelves. The specimen was vibrated 90 minutes at 220 RPM in the lateral orientation and at 200 RPM in the longitudinal direction. Testing was stopped prior to completion of the testing in the longitudinal direction due to damage to the VSTF cross members. Photo 7 shows the damaged cross members. The cross member welds failed due to forces incurred during testing.

Photo 7. Damaged VSTF Cross members.

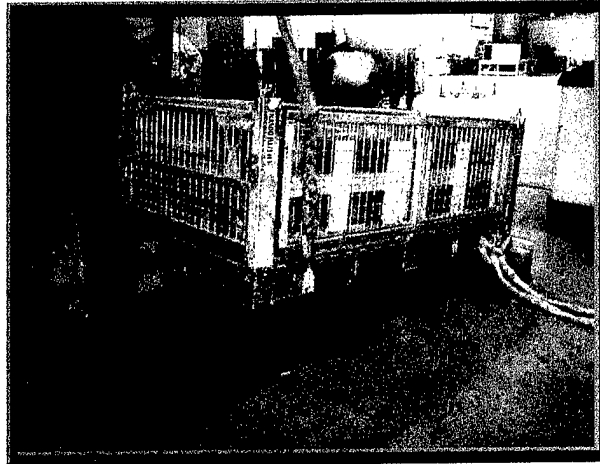
3. EDGEWISE ROTATIONAL DROP TEST. In order to identify further potential weaknesses, it was decided to continue the testing sequence on a third VSTF which was constructed using the base assembly from the first VSTF and the side panels and top shelves from the second VSTF tested. Testing was then resumed. The specimen was edgewise rotationally dropped from a height of 15

inches on both longitudinal sides and both lateral sides. Photo 8 shows the VSTF during the lateral side drop test. Welds at opposite corners and the three center cross members were broken during testing. Since the VSTF retained adequate integrity and was still considered safe to handle, testing was continued.

Photo 8. Drop Test on the Lateral Sides of the VSTF.

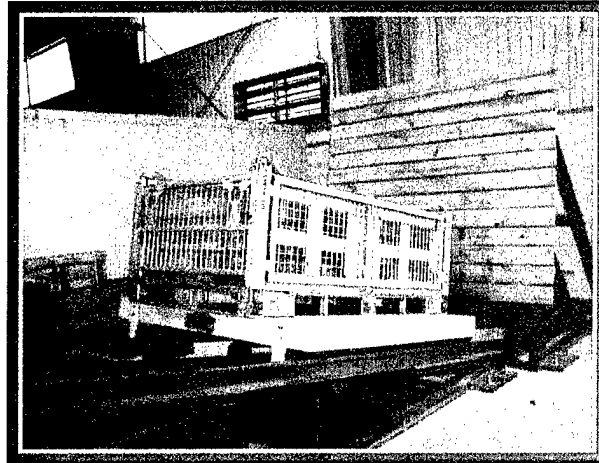
4. INCLINE-IMPACT TEST. The VSTF was impact tested on both longitudinal sides and both lateral sides. See Photo 9 for the VSTF during the lateral incline-impact test. Final inspection upon completion of testing revealed that the VSTF had numerous cracked welds on the base frame, bowing in the sides and the tabs in the top shelves bent. Photo 10 shows the bent top shelf tabs of the VSTF. Testing was continued since the VSTF retained adequate integrity and was still considered safe to handle.

Photo 9. Incline-Impact Testing of the VSTF

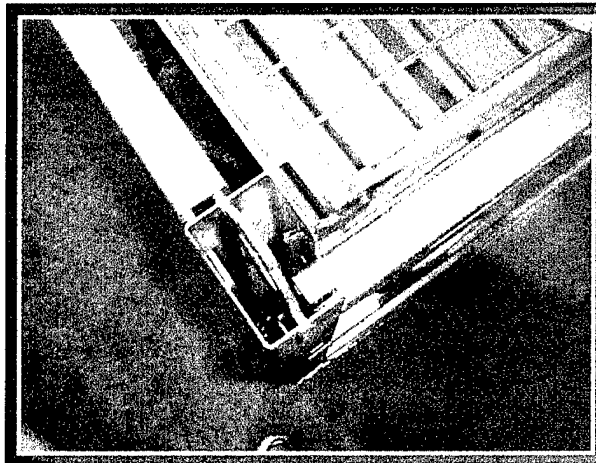
Photo 10. Bent Tabs of VSTF

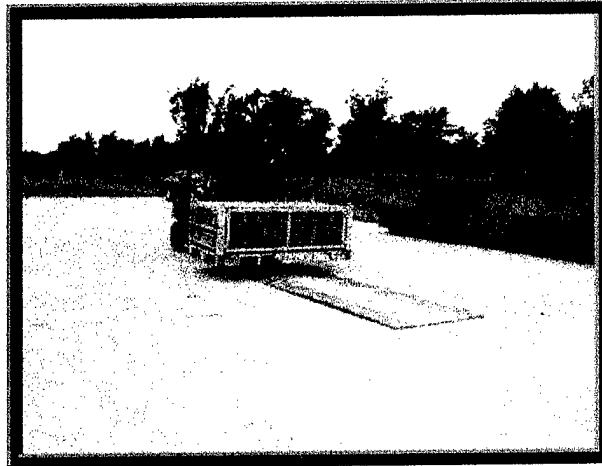
6. FORKLIFTING TEST. The VSTF was lifted clear of the ground by a forklift from both longitudinal sides and both lateral sides and transported on the forks. Photo 11 shows the VSTF during the Forklift Test. No additional damage occurred and the testing was continued since the VSTF retained adequate integrity and was still considered safe to handle.

Photo 11. VSTF during the Forklifting Test

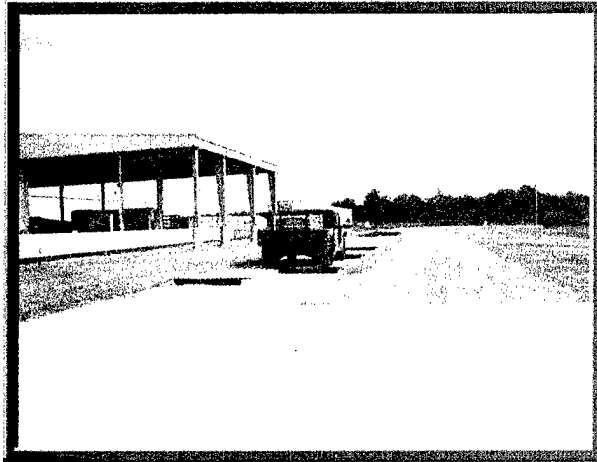
- Figure 4 lists the average speeds of the test load through the Hazard Course Passes 1 and 2.
- No additional damage occurred and the testing was continued since the VSTF retained adequate integrity and was still considered safe to handle. Photo 12 shows the VSTF during transport over the Hazard Course.

Photo 12. VSTF during Hazard Course Transport

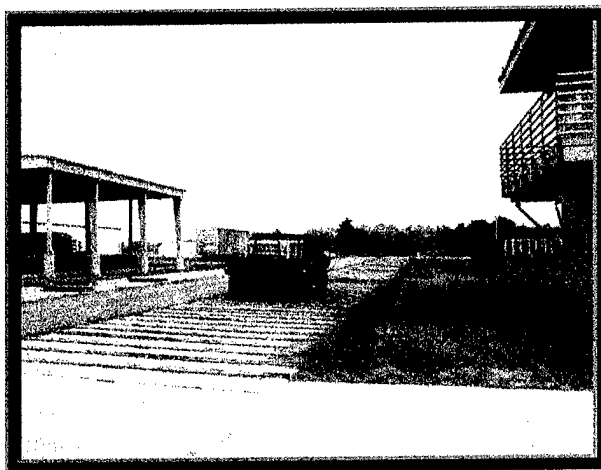
e. **WASHBOARD:** No additional damage occurred and the testing was continued since the VSTF retained adequate integrity and was still considered safe to handle. Photo 13 shows the VSTF during transport over the washboard course.

Photo 13. VSTF during Washboard Testing

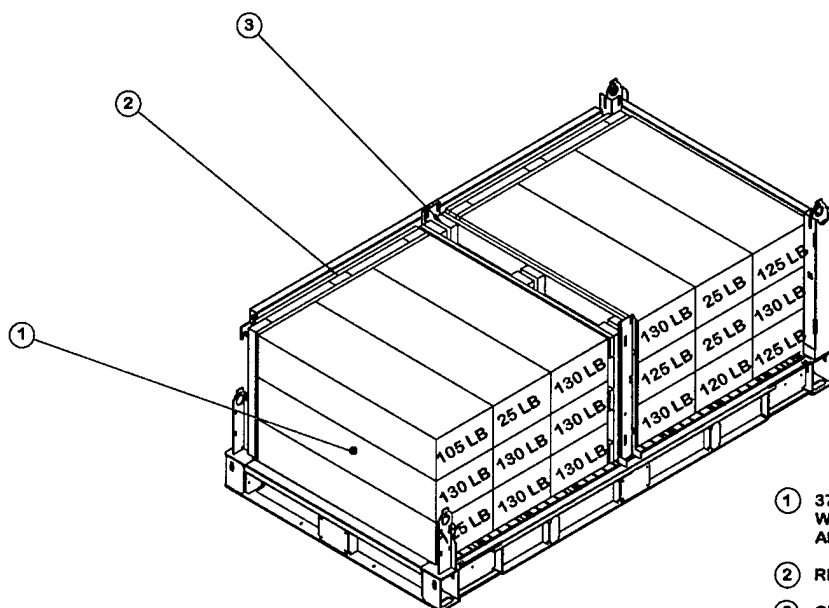
V-STF UNIT LOAD

**OVERALL DIMENSIONS OF THE V-STF:
81-3/4"L X 45-1/8"W X 33-1/16"H**

- ① 37-1/4"L X 12"W X 7-1/2"H, 105MM WOOD BOXES, WEIGHTED AS SHOWN ABOVE, LOADED AS SHOWN ABOVE, 18 REQUIRED.
- ② REAR ASSEMBLY, SEE DETAIL BELOW, 2 REQUIRED.
- ③ CENTER ASSEMBLY, SEE DETAIL BELOW, 2 REQUIRED.

18 BOXES OF 105MM HOWITZER AT (VARY) - - - - -	1,970 LBS (APPROX)
DUNNAGE - - - - -	55 LBS (APPROX)
V-STF - - - - -	370 LBS
<hr/>	
TOTAL WEIGHT - - - - -	2,395 LBS (APPROX)
CUBE - - - - -	70.6 CU FT (APPROX)
